ASSESSMENT REPORT - Extended Warranty Claim Inspection

| Manufacturer | LAND ROVER | Registration Number | [REDACTED] |
| Model | DISCOVERY 4 3.0D | Register Number | [REDACTED] |

Report No: 2016465412

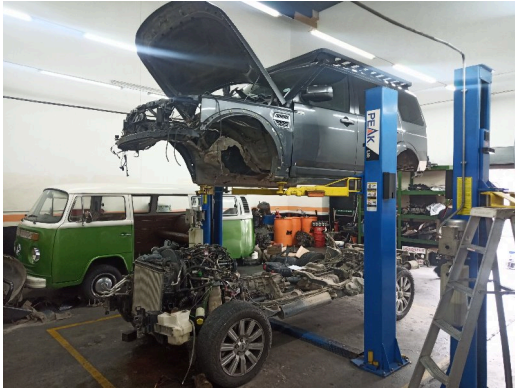
At the time of the inspection, the body had been lifted from the chassis. No mechanical parts had been disassembled. Because the body had been lifted, we could not perform a diagnostic test. Inspected the external of the engine and the noted repairs that were done and found the sensor and vacuum line that was repaired by the workshop weren't relevant to the "runaway" of the engine. We did however find a crack in the left side turbo and upon further inspection also found a massive amount of oil coming out of the intake pipe coming from the defective turbocharger. All other parts on the engine exterior seem to be in good order.

Split vehicle

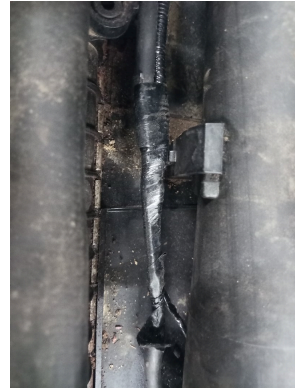
Wiring & vacuum pipe

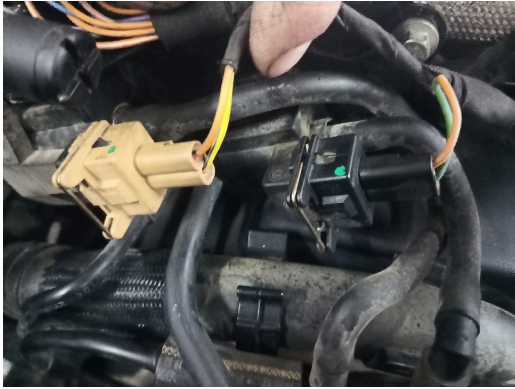
chambers. Once the oil enters the intake system, it mixes with the air-fuel mixture and is drawn into the combustion chamber. Unlike diesel fuel, the amount of engine oil entering the combustion chamber is not regulated. The engine starts to burn the oil as fuel, leading to uncontrolled and excessive combustion. The engine's RPM increases uncontrollably as it continues to draw more oil, exacerbating the problem. As the engine speed increases, more oil can be drawn through the damaged seals, fueling the runaway condition further. The engine can overheat, leading to severe internal damage and further damage to the turbocharger. **The failure is not considered to be related to the previous repair of the wiring.**

Flow sensors (wiring repairs)

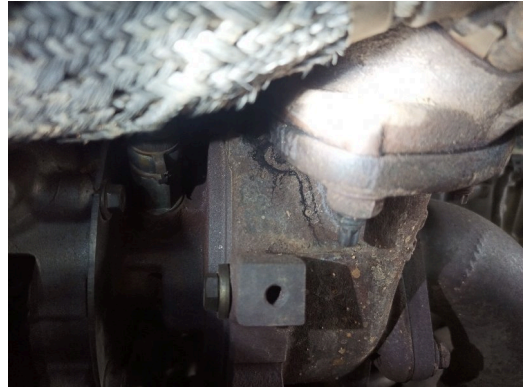
From the assessor's point of view, the crack in the turbocharger and the excessive lubricant in the intercooler pipe leads to the conclusion that the turbocharger seals failed. This resulted in lubricant bypassing the seals and entering the intake system of the engine. This would result in the lubricant entering the combustion

Turbo (L/side)

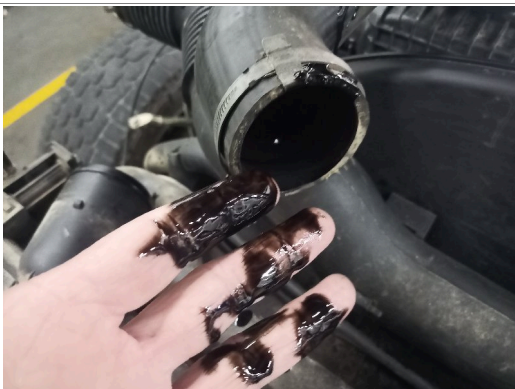
Intercooler pipe

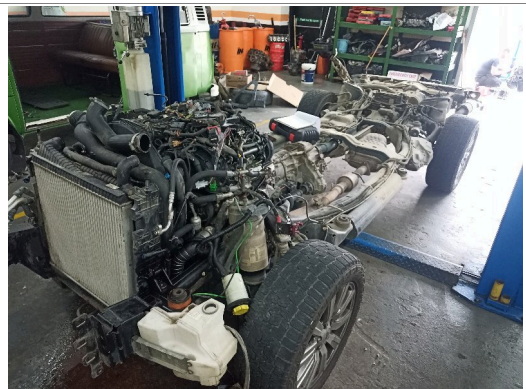
Engine & chassis
